NATIONAL AERONAUTICS AND SPACE ADMINISTRATION

MISSION OPERATIONS REPORT

APOLLO 13

APRIL 28, 1970

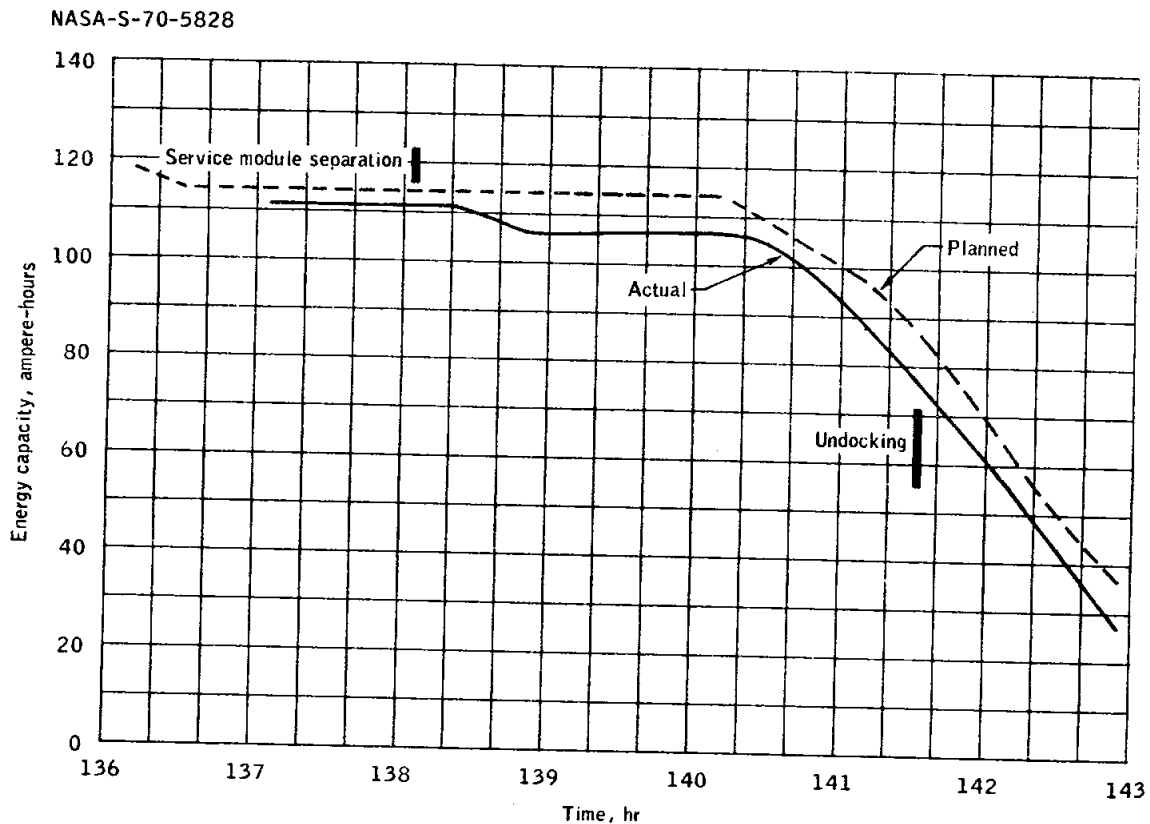
Figure 7.1-1.- Entry battery energy.

The command module was completely powered down at 58 hours 40 minutes, at which time 99 ampere-hours remained in the three entry batteries. By charging the batteries with lunar module power, available battery capacity was increased to 118 ampere-hours. Figure 7.1-1 depicts the battery energy available and used during entry. At landing, 29 ampere-hours of energy remained.

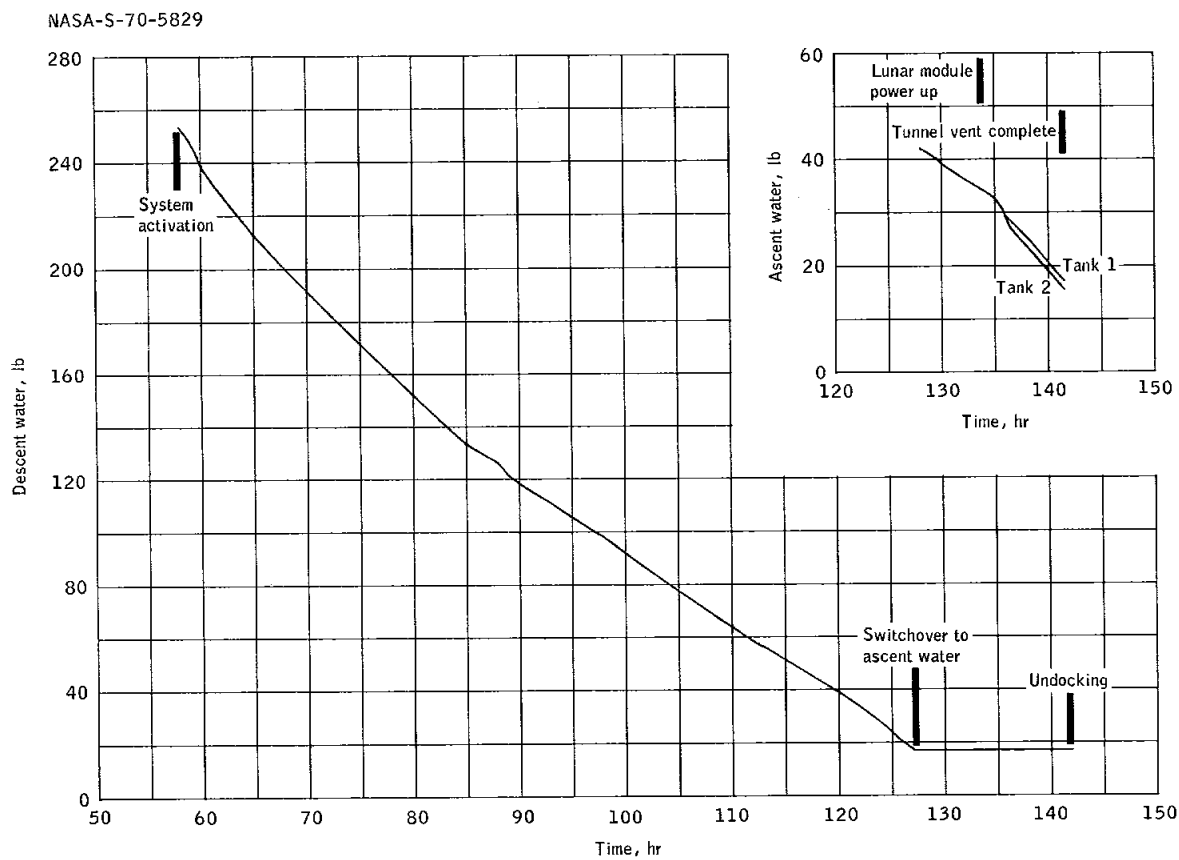
Figure 7.2-1.- Lunar module water usage.

At the time of the incident, about 38 pounds of water was available in the potable water tank. During the abort phase, the crew used juice bags to transfer approximately 14 pounds of water from the command module to the lunar module for drinking and food preparation.

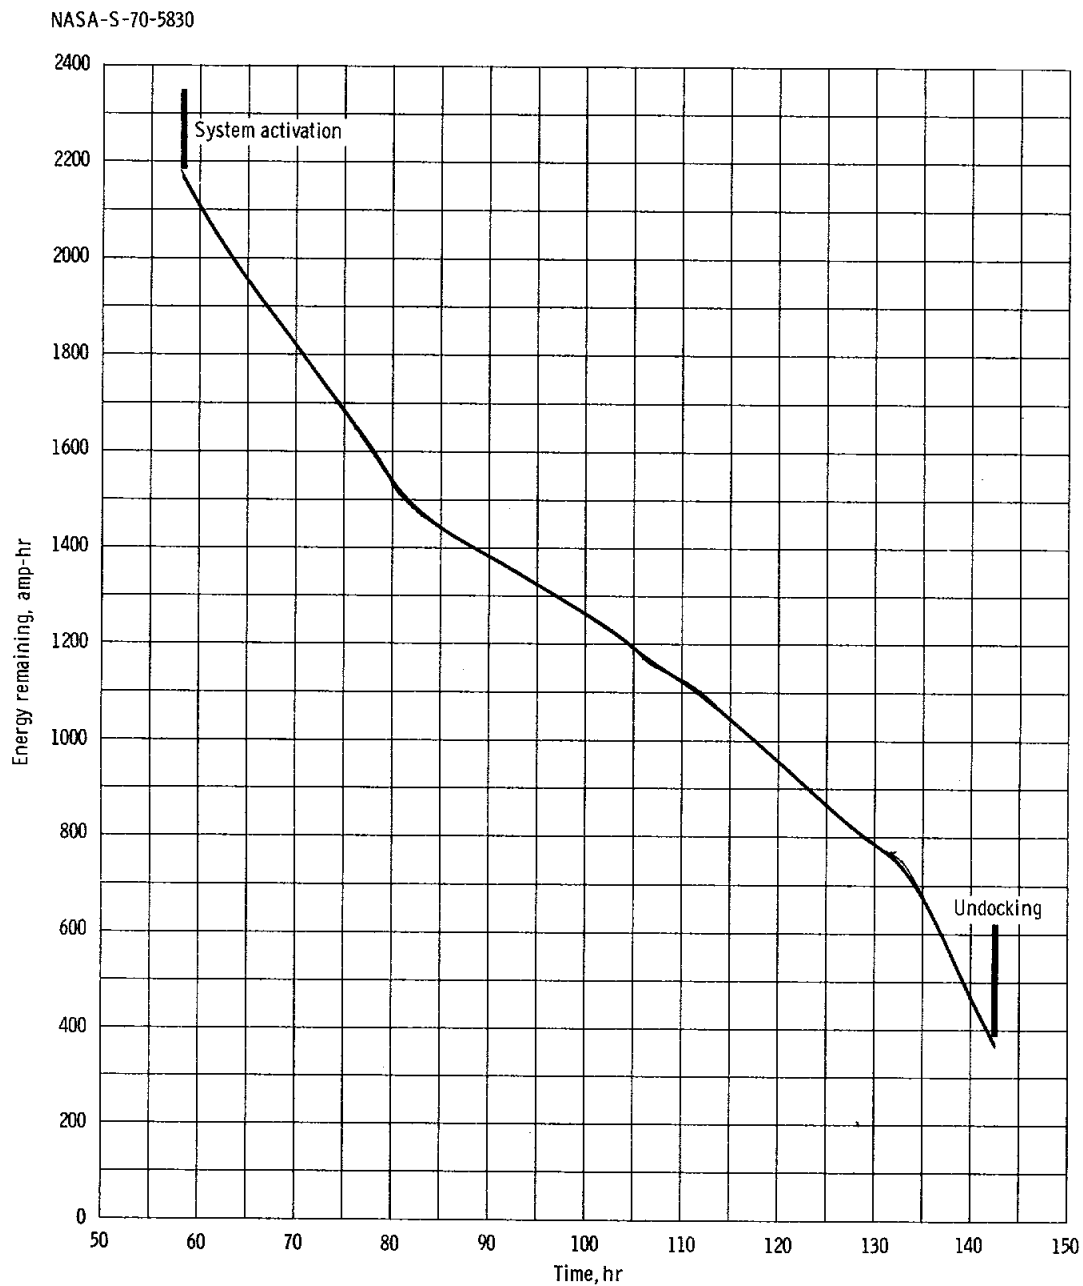
Figure 7.2-2.- Lunar module total battery capacity during flight.

operate the reaction control heaters and telemetry equipment. The estimated total energy transferred to the command module was approximately 129 ampere hours. A total of 410 ampere hours remained in the lunar module batteries at the time of undocking.

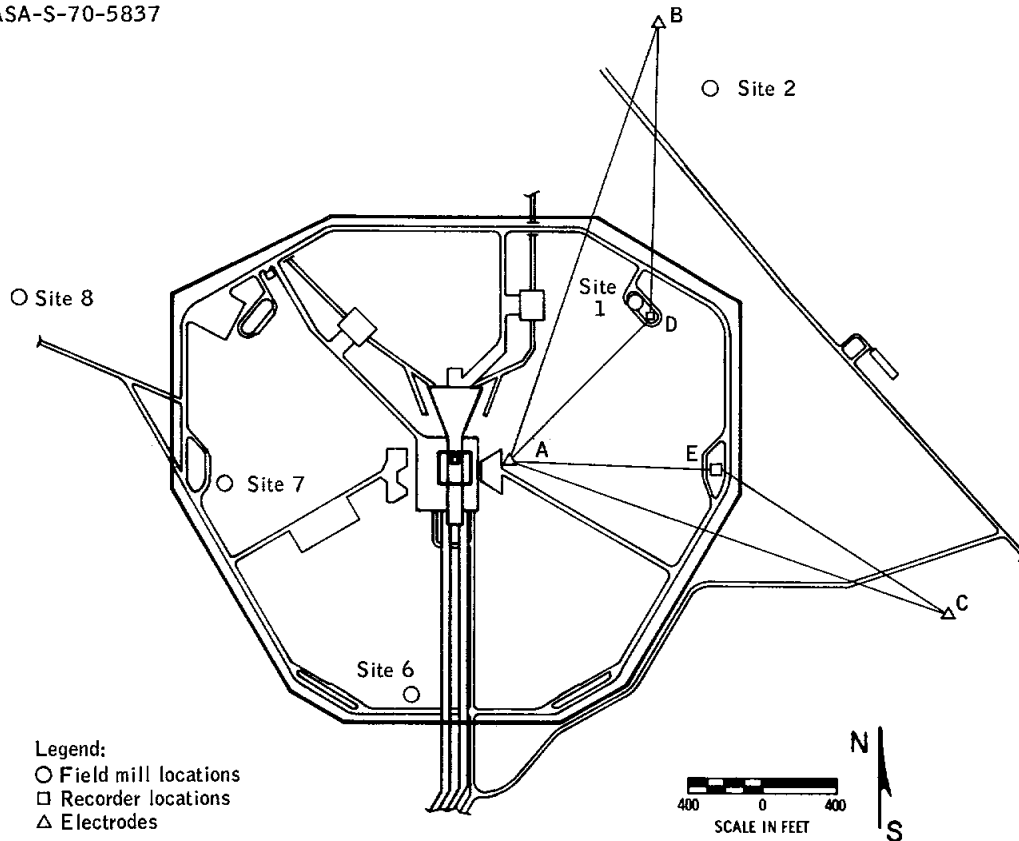
Figure 11.1-2.- Field meter locations in the proximity of the launch complex.

gravel and dust stirred up by the exhaust of the launch vehicle engine. After launch, a quantity of such debris was found near the surface of the field meter and its surrounding area. After the oscillations had subsided at T plus 40 seconds, there was a large negative field of approximately minus 3000 volts/meter which probably resulted from the exhaust and steam clouds that tended to remain over site 6.

Because of access restrictions to sites 8 and 9, the corresponding recorders were started several hours prior to launch and unfortunately had stopped before lift-off. However, substantial positive and negative field perturbations found on the stationary parts of the records were greater than anything found on the moving portion. Comparison of these records with those from sites 6 and 7 confirmed that the only large field perturbations were those accompanying launch. Consequently, the peak excursions of the records at sites 8 and 9 could be confidently associated with the maximum field perturbations occurring just after lift-off.

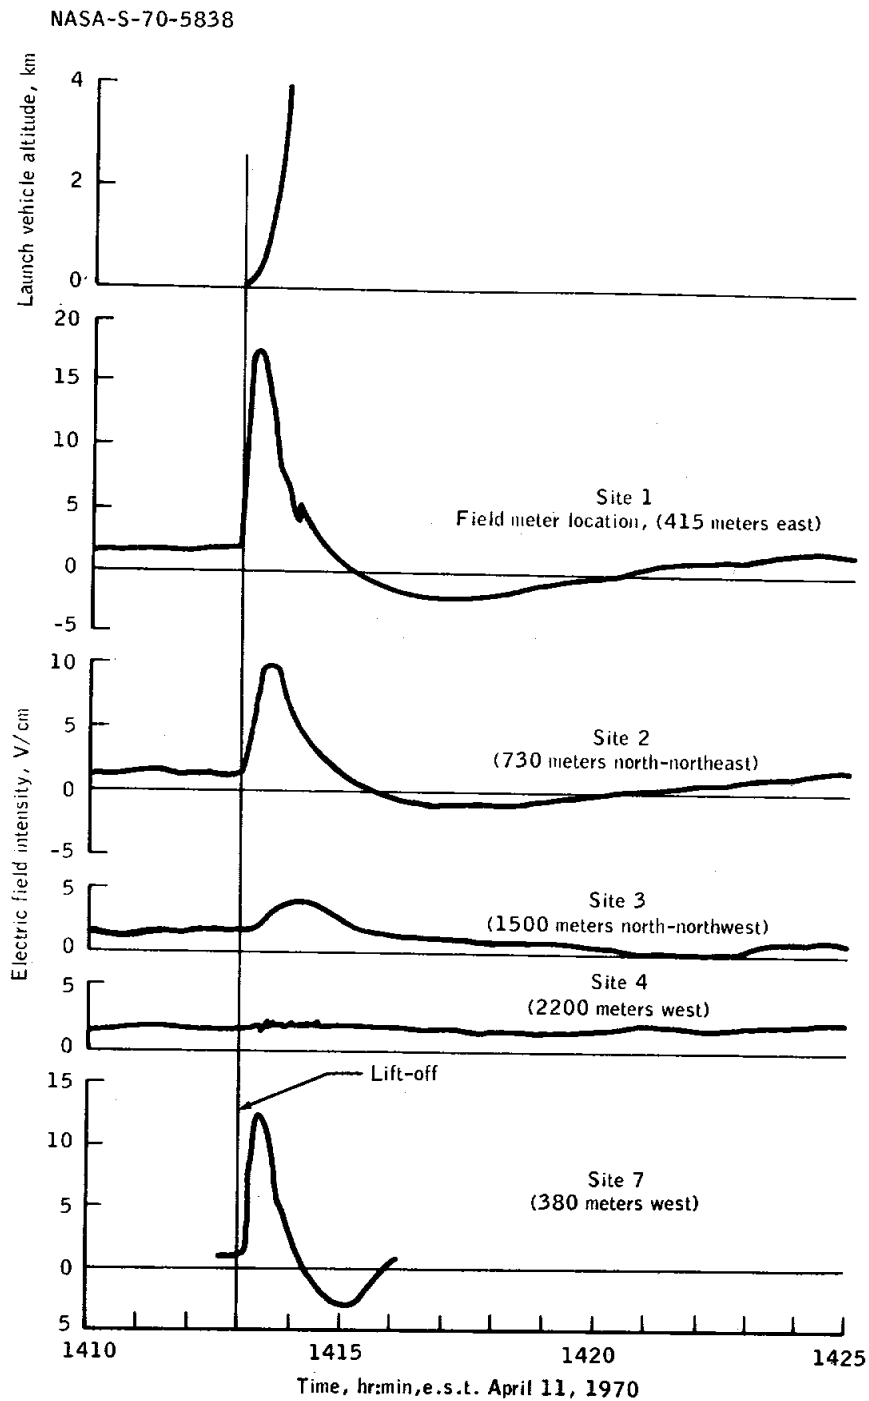
Figure 11.1-3.- Electrical discharge data for the Apollo 13 launch.

(a) Sites 1 to 4 and 7.

The above field meter records indicate the launch of the Apollo 13 vehicle produced a significant separation of electrical charge which could possibly increase the hazard in an otherwise marginal weather situation. At the present time the location and amount of the charge on the vehicle or exhaust clouds or a combination thereof are not well understood.

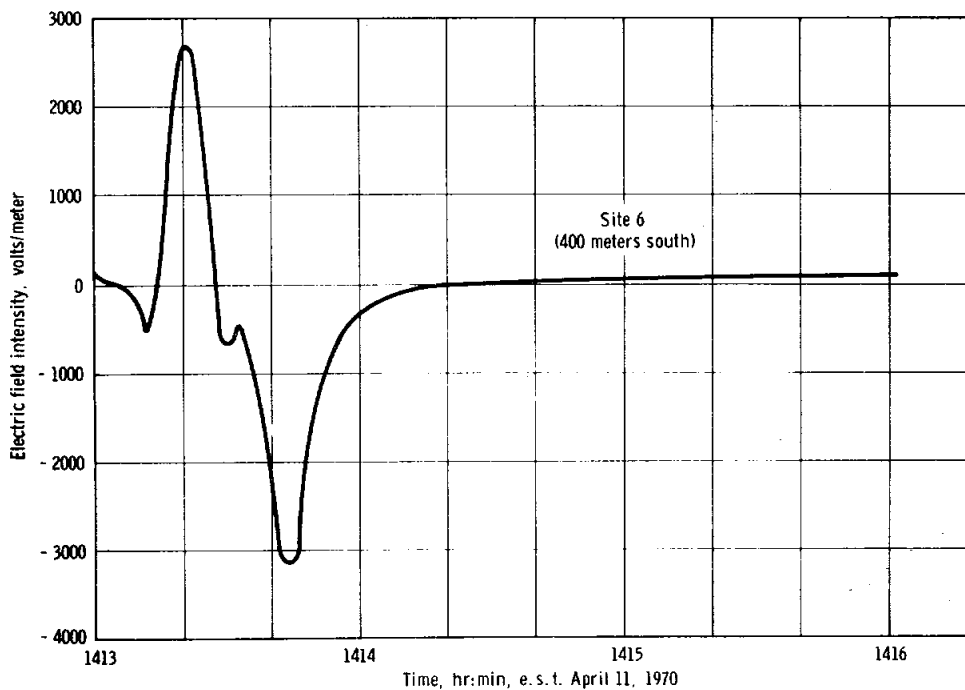
Figure 11.1-3.- Concluded

(b) Site 6.

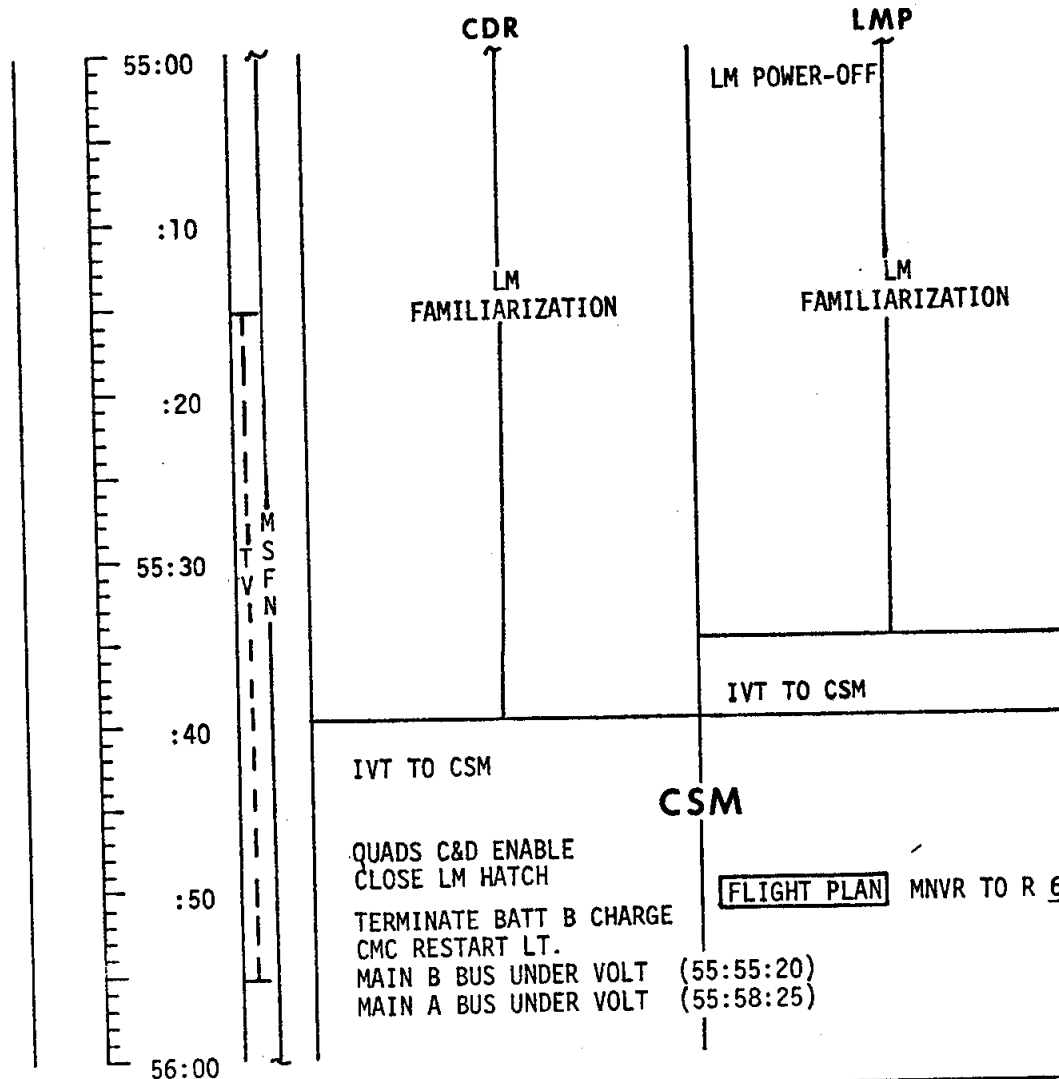
FIRST INDICATION OF SYSTEM MALFUNCTION
