NATIONAL AERONAUTICS AND SPACE ADMINISTRATION

MISSION OPERATIONS REPORT

APOLLO 13

APRIL 28, 1970

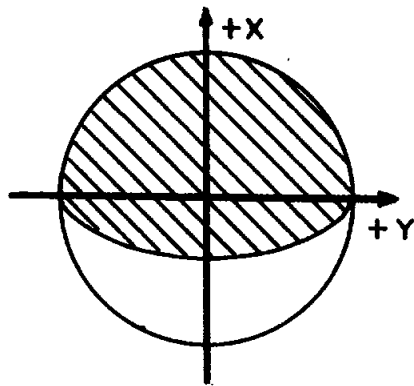
POSIGRADE

D. Since the crew could not find stars in the AOT before going behind the moon prior to PC+2, a method of executing the midcourse maneuvers was recommended using the earth terminator aligned on the horizontal line of the COAS with the COAS mounted in the FWD window looking down the LM +Z body axis. The sunlit part of the earth could be placed in the COAS as shown below for either a posigrade or retrograde burn.

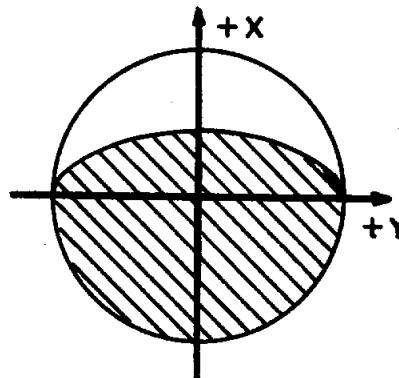
RETROGRADE

MCC-5 was executed with the AGS body axis aligned using the retrograde alignment. A REFSMMAT OST 009 was computed that was equivalent to the above alignment, for use by other MOCR positions and by MPAD in their processors. AGS addresses 404, 405, 406 were loaded with zeros. The burn was monitored by 470R. The AGS accelerometer drift at T_{IGN} was determined to be $-.2$ fps. The burn was cutoff by the crew at 7.4 fps and trimmed to 7.6 in 470.

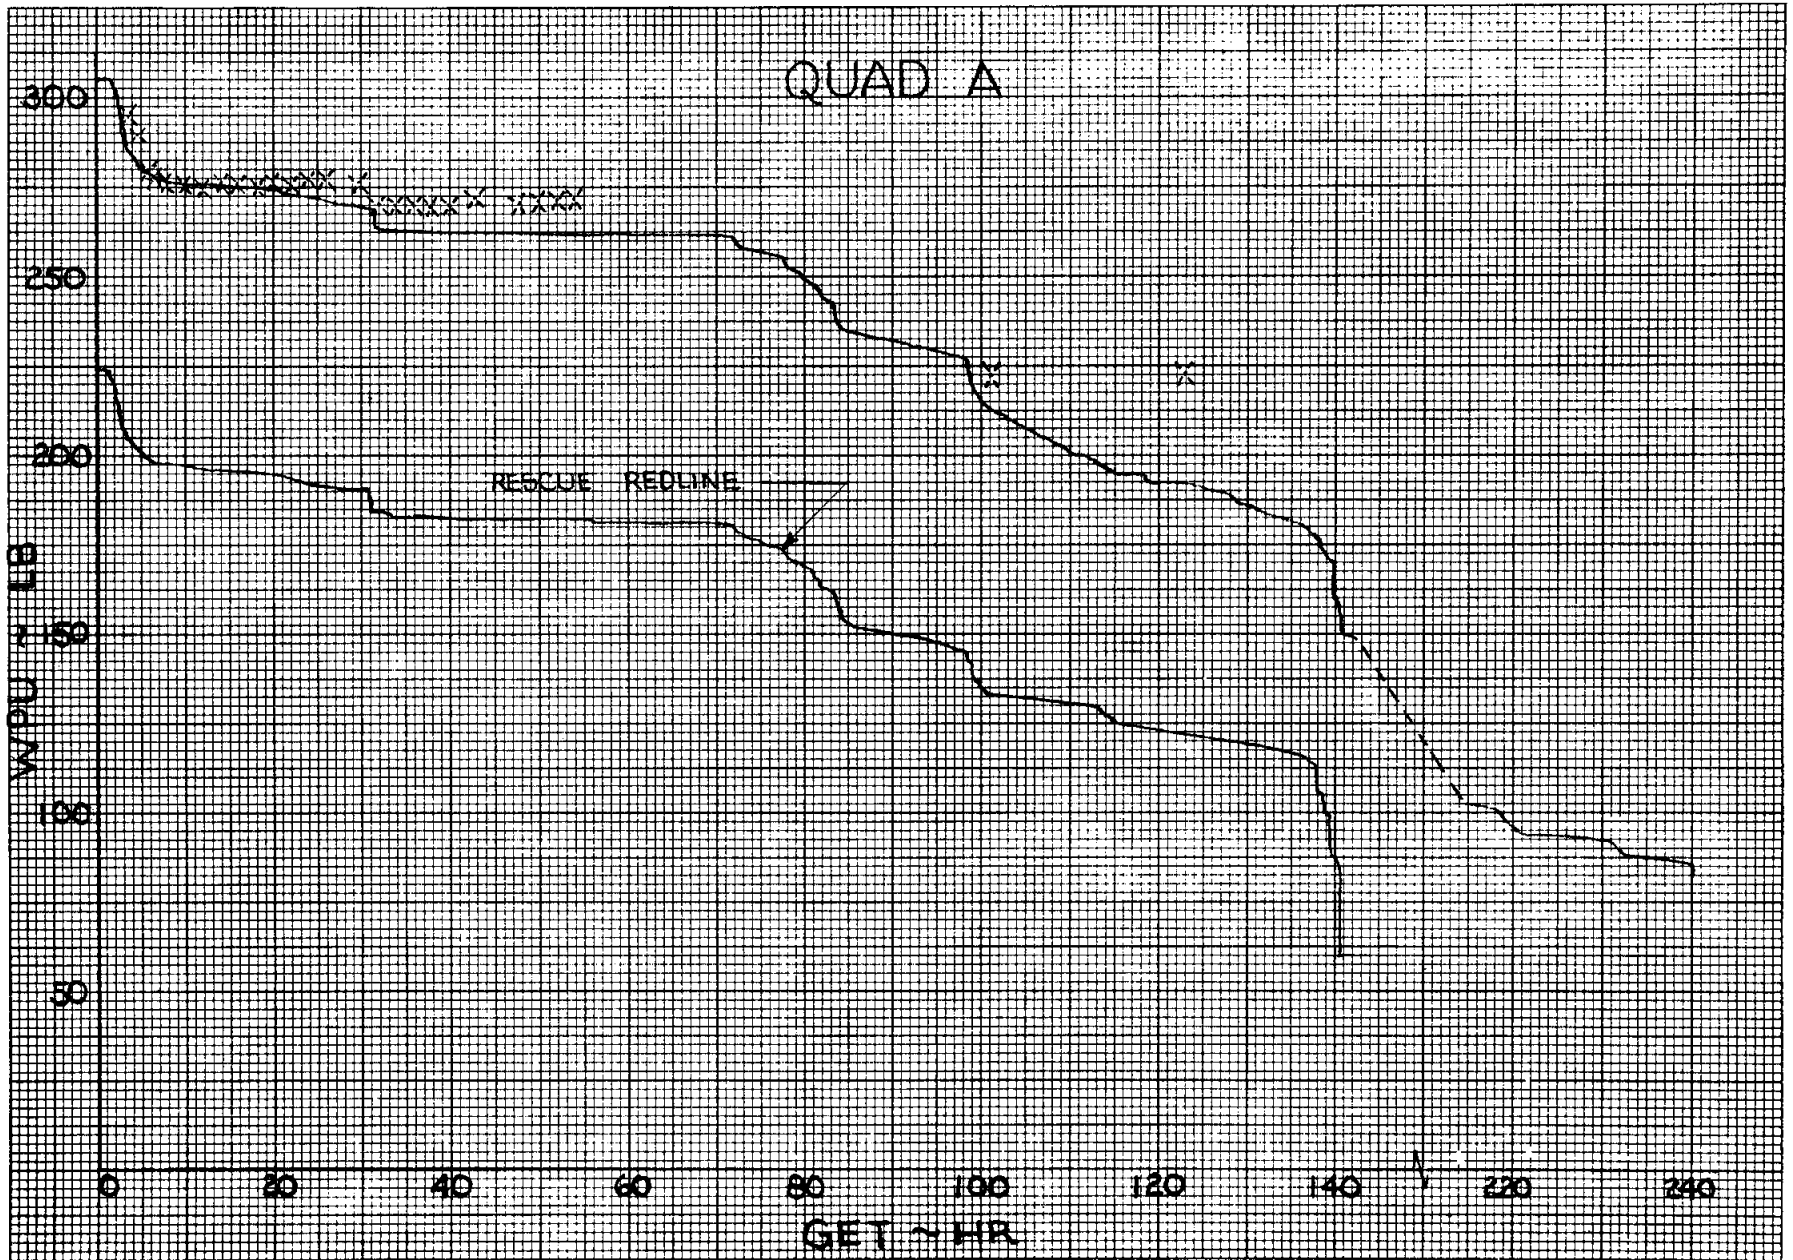
FIGURE 1

Subsequently, the crew reported continued trouble damping the vehicle rates. This was because the DAP had A/C roll selected and the crew had turned off thruster A1. With this configuration \pm Yaw, -Pitch and -Roll was the only control available. There was at this time no indication of Quad C propellant usage forcing the conclusion that either the fuel and oxidizer primary propellant isolation valves were closed or that Quad C was inoperable because of damage. Since both the propellant valves and their talkback indicators required MNB power, the anomaly was left open. The crew subsequently selected B/D roll in the DAP and selected MNA on the RCS jet selects to regain auto control. Figures 1 through 4 show the SMRCS propellant usage on this flight.
